NATIONAL TRANSPORTATION SAFETY BOARD

SAFETY RECOMMENDATIONS

ADOPTED JULY 2002

Date: July 3, 2002

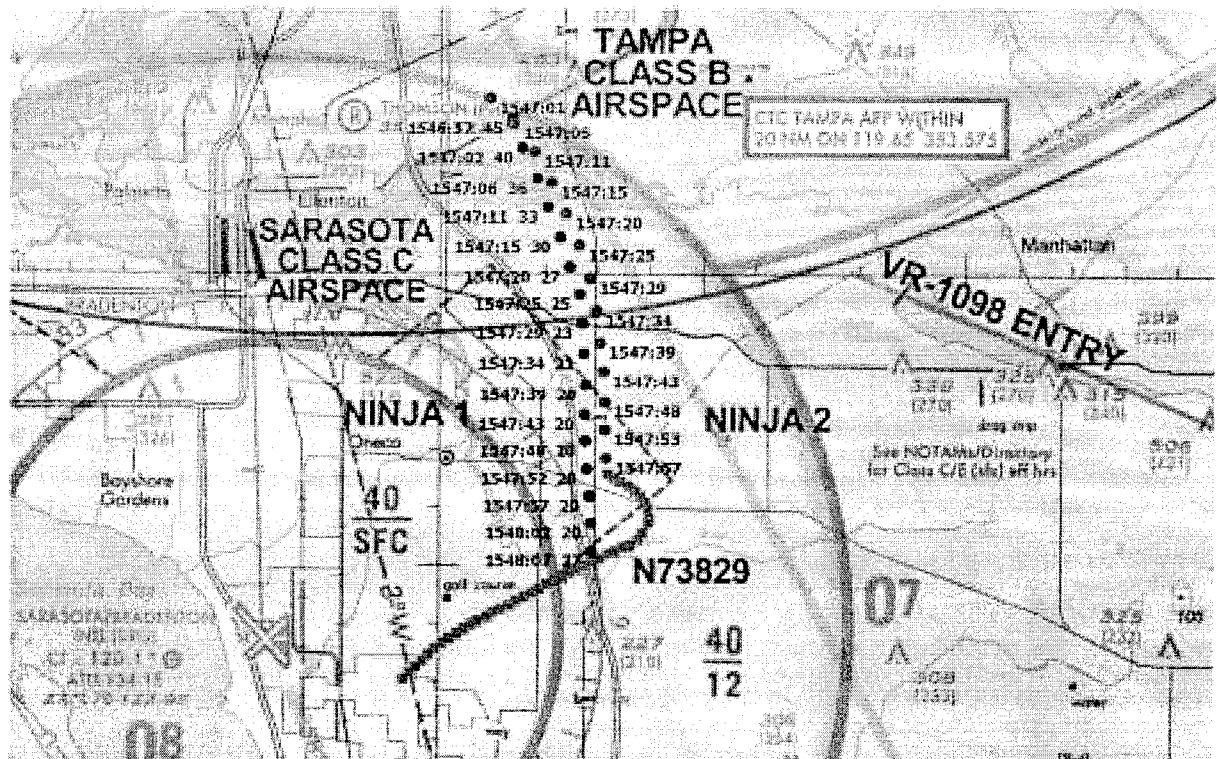
At 1544:34, after trying, unsuccessfully, to contact Tampa TRACON several times, the pilot of Ninja1 reestablished contact with Miami ARTCC and informed the controller that he wished to cancel his IFR flight plan. The controller accepted the cancellation and asked the pilot if he wished to continue receiving radar traffic advisory services. The pilot declined. The controller instructed Ninja1 to set code 1200 (standard for visual operations) in the aircraft's radar transponder and terminated radar traffic advisory services. Ninja1 then began a VFR descent to enter VR-1098. (See figure 1.)

Figure 1. Radar tracks showing the flightpaths of Ninja1, Ninja2, and N73829.
